# **Notes of GARD visit to SESRO Clay Compaction Trial site 20<sup>th</sup> May 2025**

## **Summary**

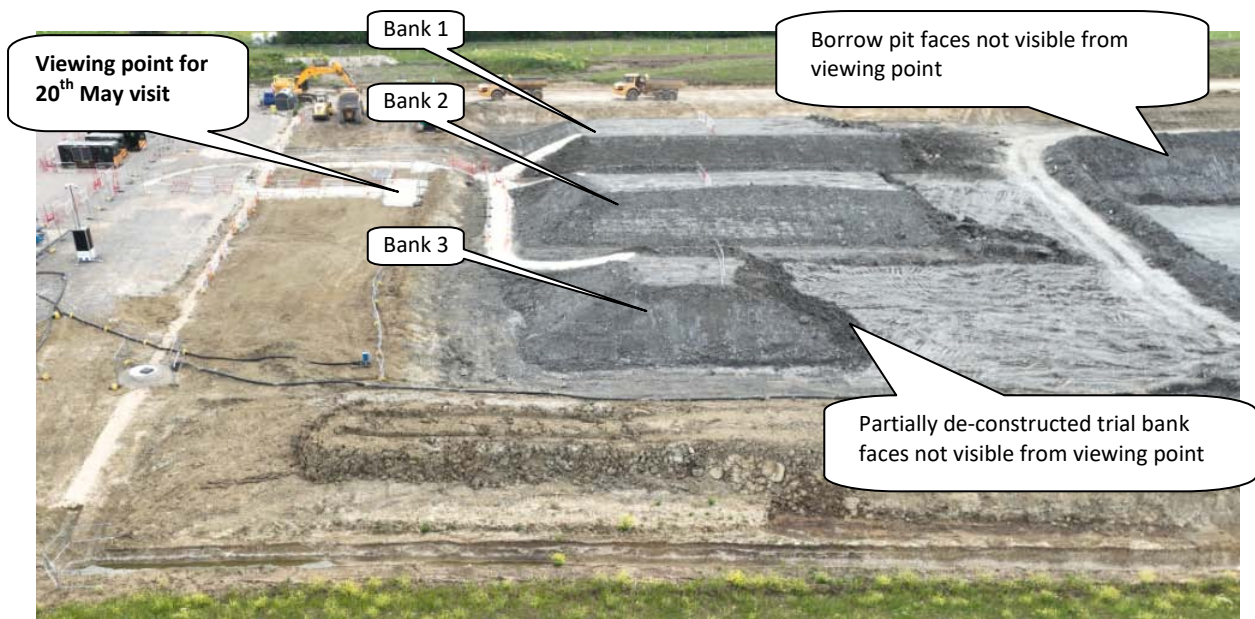
Therefore, the trial banks were viewed from the location shown below (taken from GARD drone photography on 17<sup>th</sup> May 2025):

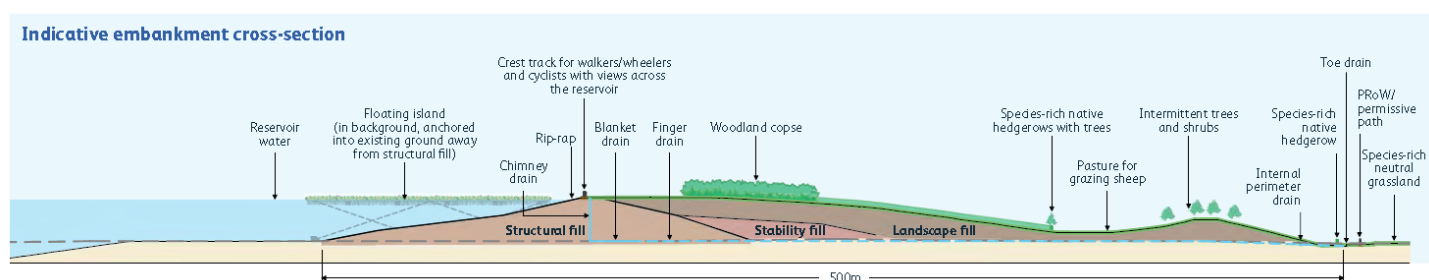
The TW liaison officer asserted that it had been a separate clay core embankment design in the pre-DCO consultation in summer 2024. She did not change her view even when MG read the appropriate extract from the consultation document which made no mention of a separate clay core and shoulders and showed the cross-section below<sup>4</sup>:

This diagram shows a homogeneous ‘structural fill’ and a chimney drain located in the in the centre of the dam – where the clay core would be if the dam is designed with a clay core and separate shoulders.

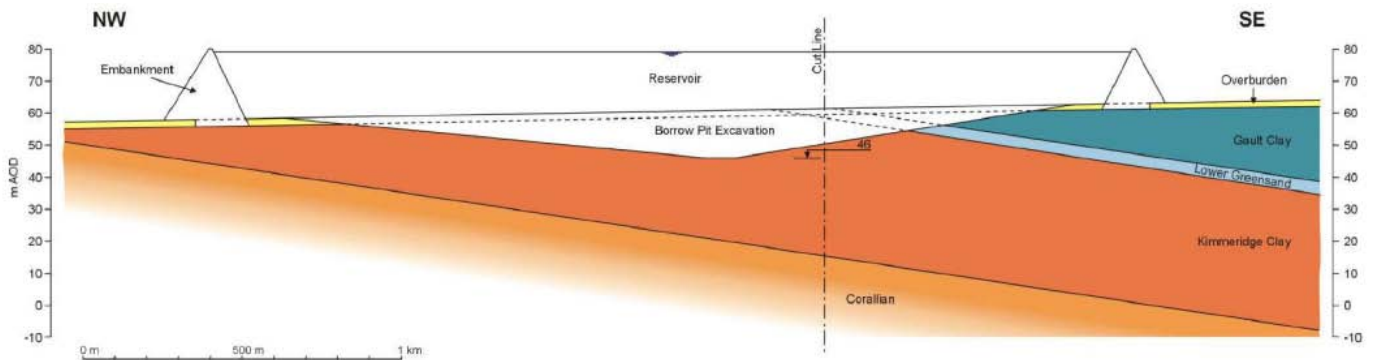
The dip slope of the geological layers at the borrow pit site means that, at a given depth of the borrow pit, different geological layers will be encountered in different areas of the pit, with potentially different geotechnical properties, as illustrated below<sup>5</sup>:

In addition to encountering Gault Clay and Greensand in some parts of the full scale borrow pit, at a given depth of the borrow pit, different layers within the Kimmeridge Clay will be encountered. The trial borrow pit seems to have revealed that there is considerable variation in geotechnical properties of different layers within the Kimmeridge Clay (as well as variation in moisture content). It appears that this variation, with some layers being found unsuitable for compaction into an impermeable layer, has led to the change from a homogeneous clay bank to a separate clay core and shoulders, although this is denied by TW and Binnie staff.

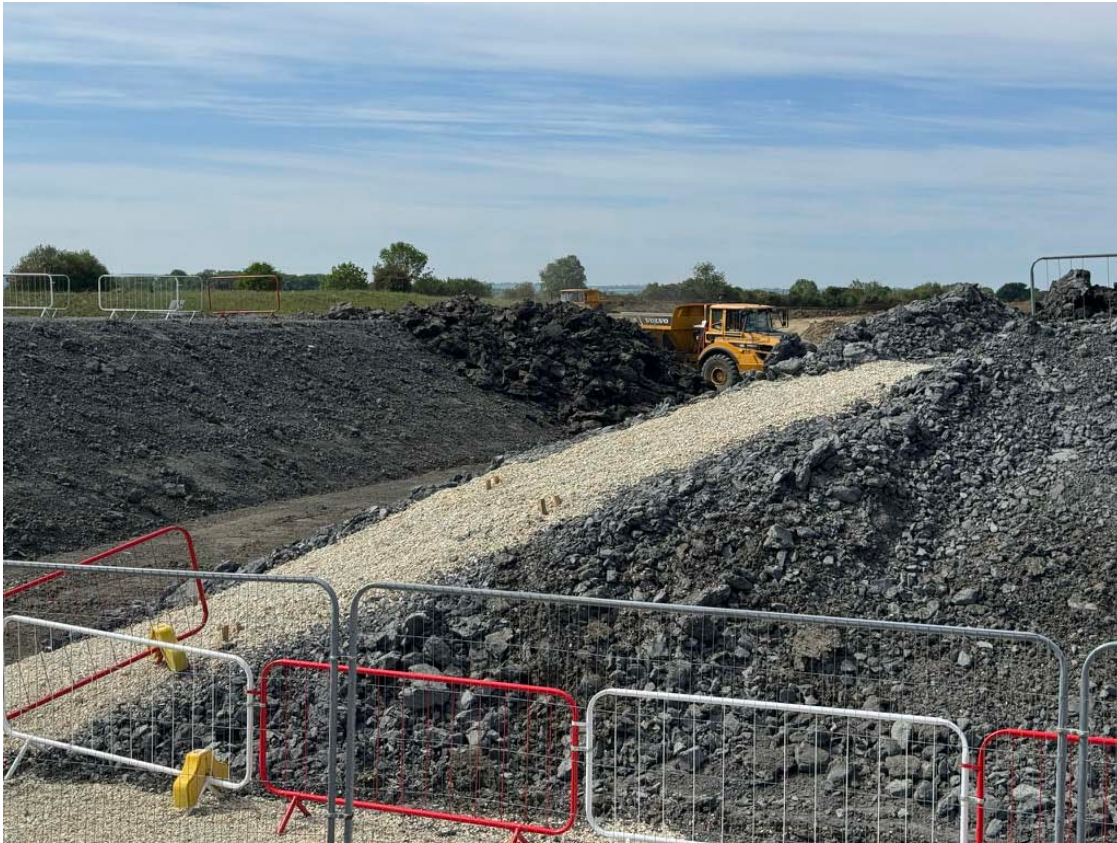
**General view from viewing point - Bank 1 on the left and Bank 2 on the right:**

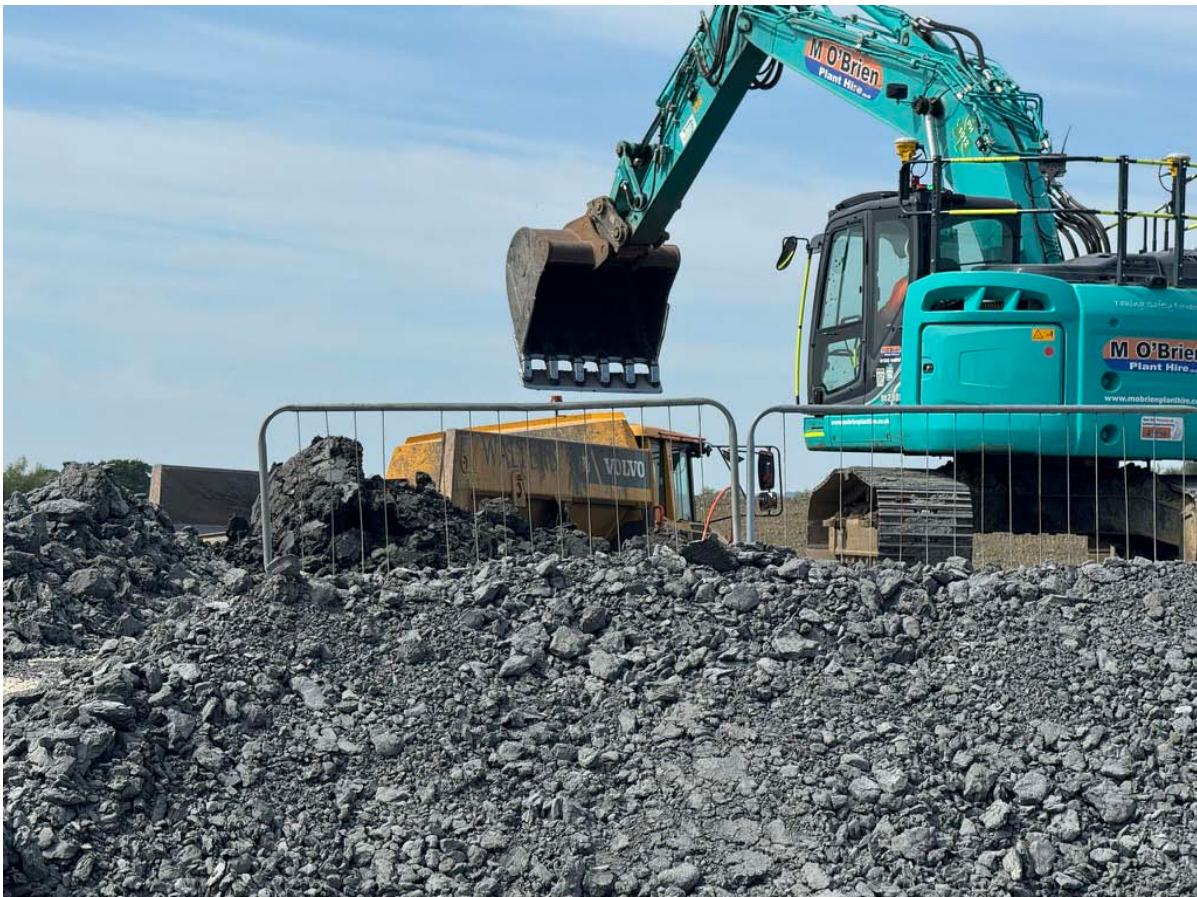
We could see the material that an excavator on Bank 2 (ie coming from 3 -7 m depth in the borrow pit) was tipping into a dump truck. From what we could see, this did not look well bonded, coming out as loose soil and occasional blocks of clay.

**Photo of the Bank 2 being de-constructed:**
